GPMP 2005	GRID SQUARE(S) 101. Z 28-29	ARCHITECTURE	CONTEXT 7 WALL (21876)
1. Material	1) MUD BRICK. 2) BRICKS VARY FROM 17CM W X 39CM L, 19CM W X 37CM L, 20CM W X 40CM L. 3) SOURCES

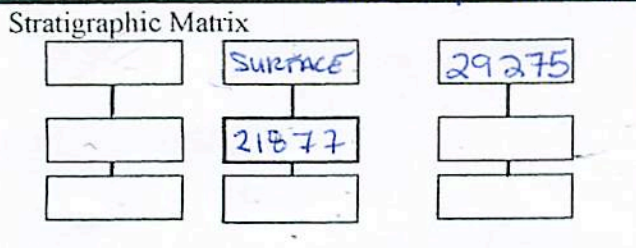
3 Courses of brick

Abuts 21876 - N/S WALL Above
 X + X abut each other, at present study
 Abutted by Below unclear
 Bonded into
 Contiguous with

INTERPRETATION	Enclosing	Internal	External
Reason for decay	LEFT EXPOSED SINCE 1932-1933 TRAMPLED BY HORSES		
Indications of original dimensions	ON W SIDE WHERE ABUTS WALL 21876, PLASTER/MORTAR LINE VERY CLEAR. WALL MELT APPEARS TO FLOW		
Indications of original functions	SOUTH Z 29 - 29
