GPMP 2007	GRID SQUARE(S) 201-035	ARCHITECTURE	CONTEXT 29047 29047
1. Material	1/. Mudbrick 2/. - 3/. -		
2. Size of materials	4/. Two rows of masonry ^{ONE} STRUCTURE		
3. Finish	5/. E-W wall turning to south slightly in west		
4. Coursing/bond	Single running in masonry		
5. Form	6/. N/S/E/W		
6. Direction of faces	7/. N-S 8/. long LENGTH EXPOSED 3.38m WIDTH = 1.02m		
7. Orientation	9/. - 10/. - 11/. - 12/. -		
8. Dimensions	13/. Two layers continuously for around the corner		
9. Associated collapse	14/. - 15/. - niche ^{100%}		
10. Founds, cuts & fills	17/. 410 x 150mm		
11. Repaired			
12. Associated floors			
13. Plastered			
14. Wall core			
15. Types of brick (%)			
16. Composition of bricks			
17. Dimensions of bricks (sample of three)

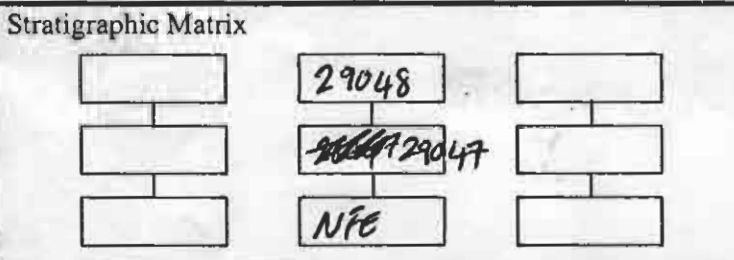
INTERPRETATION	Enclosing	Internal	External
Reason for decay			
Indications of original dimensions	LARGE E-W MUDBRICK WALL FORMING THE		
Indications of original functions	NORTH-WALL SIDE OF A MASSIVE REMAINING ONLY		
	PARTLY EXPOSED IN 2007 SEASON. THE SAME		
	BUILD STYLE TO 29026 TO SOUTH SO		
	FORMING PART OF SAME STRUCTURE / PART OF SOUTH-WALL.		
	LACK OF ANY INTERNAL DIVISIONS SO THIS MAY INDICATE THAT IT IS		
	A MONUMENTAL STRUCTURE.		
Associated contexts:	Highest 18.15 Lowest 17.87
