GPMP 2008	GRID SQUARE(S) 101. S27	ARCHITECTURE	CONTEXT 29286
1. Material 2. Size of materials 3. Finish 4. Coursing/bond 5. Form 6. Direction of faces 7. Orientation 8. Dimensions 9. Associated collapse 10. Foundations, cuts & fills 11. Repaired 12. Associated floors 13. Plastered 14. Wall core 15. Types of brick (%) 16. Composition of bricks 17. Dimensions of bricks (sample of three)	1. limestone 2. stones range 200 mm x 300 mm max 200 mm x 350 mm 50 x 30 mm 3. roughly hewn 4. random, coursing difficult to assess with remains 5. wall 6. west face, east face 7. North-South 8. 3.6m long .45 m wide 9. N/A 10. N/A 11. N/A 12. 29649 13. mudvender 14. mainly limestone, occasionally pottery fragment + small 15-17 see above		
Stratigraphic Matrix <div style="display: flex; justify-content: space-around; align-items: center;"> <div style="text-align: center;">

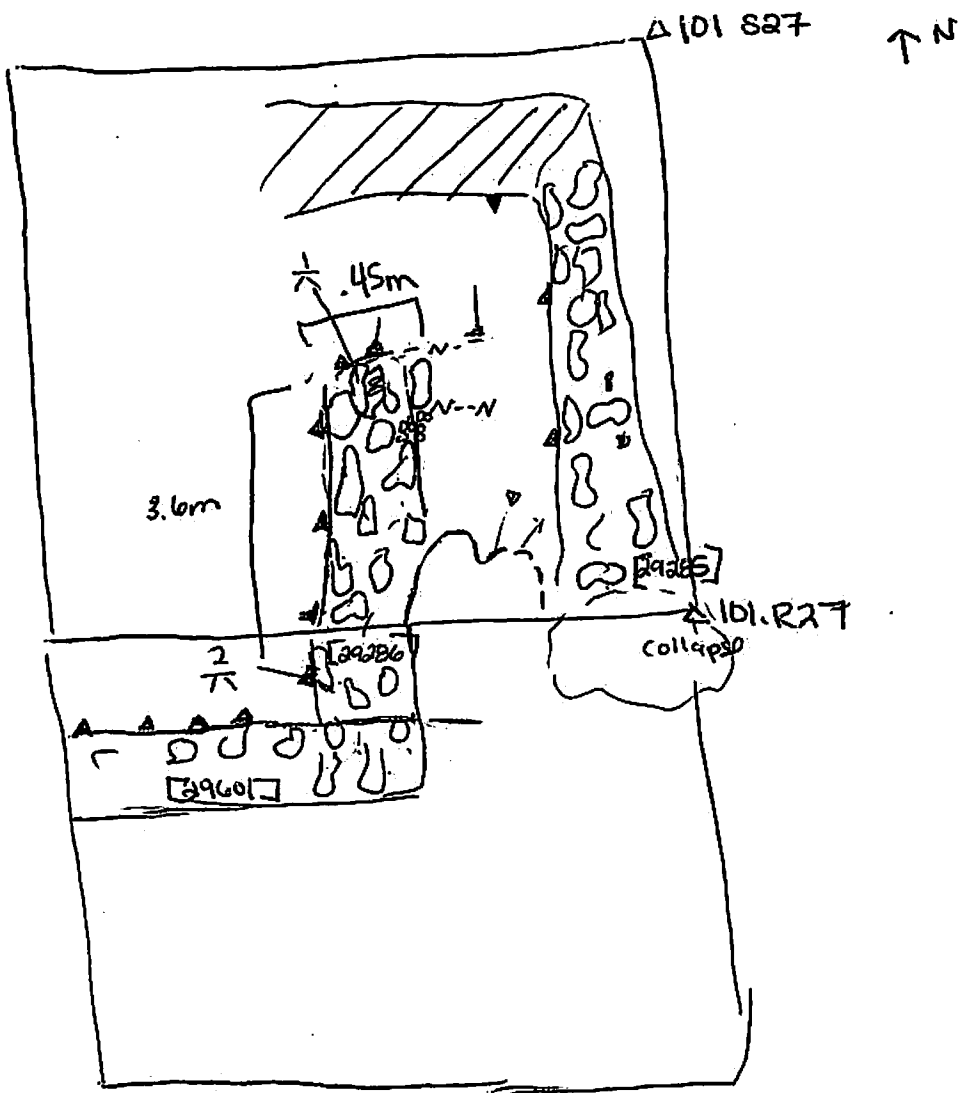
INTERPRETATION (Enclosing) Internal (External)			
Reason for decay Indications of original dimensions Indications of original functions	North-South running wall, which possibly forms ^(Probably) east but is not clear. Possibly contiguous with wall in 101. R27.		
which bonded into wall 29601. It forms a room space 187 from Salim Hassan's plan as well as room 188			
Associated contexts:			
Context Same As:
