<b>GPMP 2008</b>	<b>GRID SQUARE(S)</b> 101 Z 30	<b>ARCHITECTURE</b>	<b>CONTEXT</b> 29319
1. Material	1- Mud		
2. Size of materials	2- one Brick 40 cm x 24 cm and the other one 22 cm		
3. Finish	x 20 cm wide		
4. Coursing/bond	3- N.A 4- stretcher		
5. Form	5- Wall possibly or Installation		
6. Direction of faces	6- North-South		
7. Orientation	7- East-West		
8. Dimensions	8- 76 cm long x 20 cm to 24 cm wide.		
9. Associated collapse	9- N.A		
10. Founds, cuts & fills	10- N.A		
11. Repaired	11- N.A		
12. Associated floors	12- N.A 13- N.A		
13. Plastered	14- N.A		
14. Wall core	15- Sandy mud		
15. Types of brick (%)	16- Sand 20% and mud 80%		
16. Composition of bricks	17- see above		
17. Dimensions of bricks (sample of three)

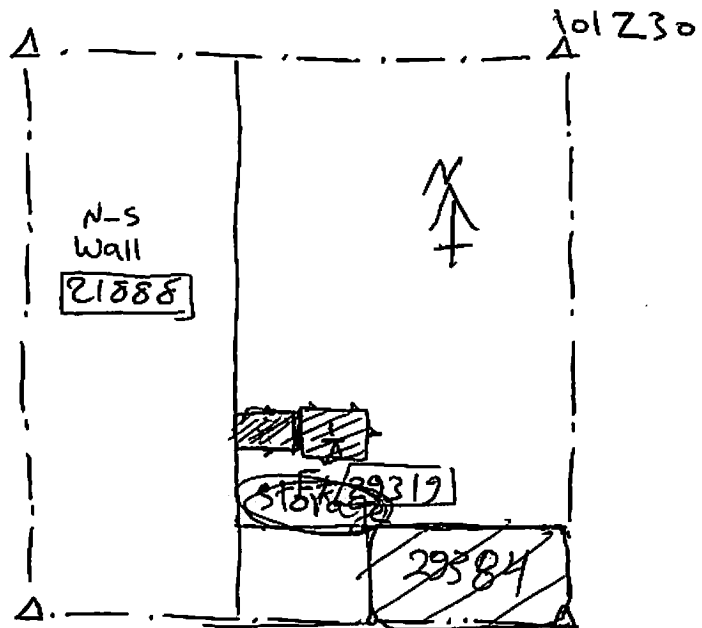
<b>INTERPRETATION</b>	<b>Enclosing</b>	<b>Internal</b>	<b>External</b>
Reason for decay	This feature is Mud Brick Installation contains		
Indications of original dimensions	of low Mud Bricks only abuts the the		
Indications of original functions	N-S wall 21888 and it overlaid fine clean		
Sand [29320] - the function of this installation is still not clear especially the Sand 20% and mud 80% it was built above Sand 29320. Maybe this installation related with the Blocked entrance (29384) To Make a storage in the corner?!
