GPMP 2008	GRID SQUARE(S) 101.529 - T29	ARCHITECTURE	CONTEXT 29561
------------------	---------------------------------	---------------------	------------------

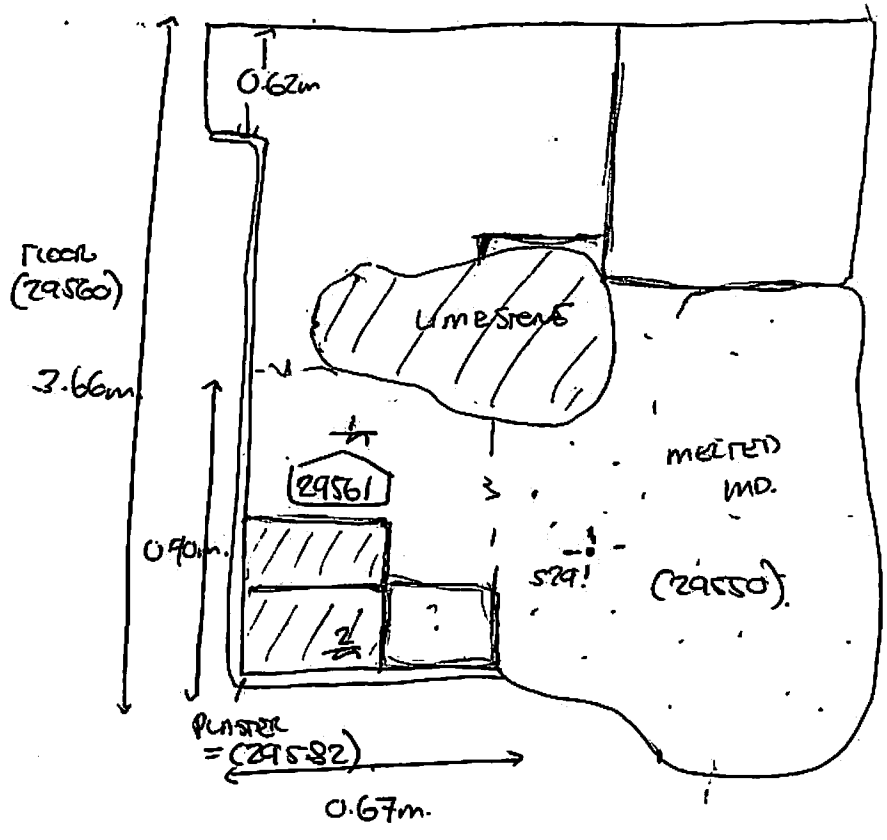
Drawing Nos: 2008.3 ; 2008.38

1. Material	① MUD-BRICK.
2. Size of materials	② BRICKS = 440mm x 240mm / 440mm x 200mm
3. Finish	③ BRICKS SCARED
4. Coursing/bond	④ 'HEADERS' & 'STRETCHERS' - BRICKWORK MODER V. FEW VISIBLE.
5. Form	⑤ N-S WALL WITH LINING (CORRIDOR CE WALL)
6. Direction of faces	⑥ W. FACING = INTERNAL ALSO S. FACING FLAG
7. Orientation	⑦ N-S
8. Dimensions	⑧ N-S = (L) 3.66m
9. Associated collapse	E-W = (W) 0.67m.
10. Foundations & fills	⑨ - ⑩ - ⑪ -
11. Repaired	⑫ (29560) ⑬ (29562) ON W. FACE.
12. Associated floors	⑭ - ⑮
13. Plastered	⑯
14. Wall core	⑰ AS ABOVE
15. Types of brick (%)	
16. Composition of bricks	
17. Dimensions of bricks (sample of three)

INTERPRETATION	Enclosing	Internal	External
Reason for decay	N-S mudbrick wall		
Indications of original dimensions	Badly eroded in the middle some mudbrick		
Indications of original functions	are still visible above the limestone crushed [29276]
