GPMP 2008	GRID SQUARE(S) 101.529	ARCHITECTURE	CONTEXT 29565
1. Material	① SILTY MUD-BRICKS.		
2. Size of materials	② 390mm x 700mm / 390mm x 190mm / 360mm x 180mm.		
3. Finish	③ SMOOTH		
4. Coursing/bond	④ BONDED w/ FINE YELLOW-GRAY SILTY SAND w/ OCCA SUB-AVG PEBBLES		
5. Form	ONLY ONE ROW POSS HEADERS REMAIN?		
6. Direction of faces	⑤ WALL FLAG. ⑥ UNCERTAIN.		
7. Orientation	⑦ POSS E-W BUT UNCLEAR.		
8. Dimensions	⑧ 0.80m approx (N-S) x 0.47m (E-W)		
9. Associated collapse	⑨ -		
10. Founds. cuts & fills	⑩ -		
11. Repaired	⑪ -		
12. Associated floors	⑫ floor ? Possibly 29576		
13. Plastered	⑬ -		
14. Wall core	⑭ -		
15. Types of brick (%)	⑮ ALL STAY.		
16. Composition of bricks	⑯ -		
17. Dimensions of bricks (sample of three)	⑰ AS ABOVE.

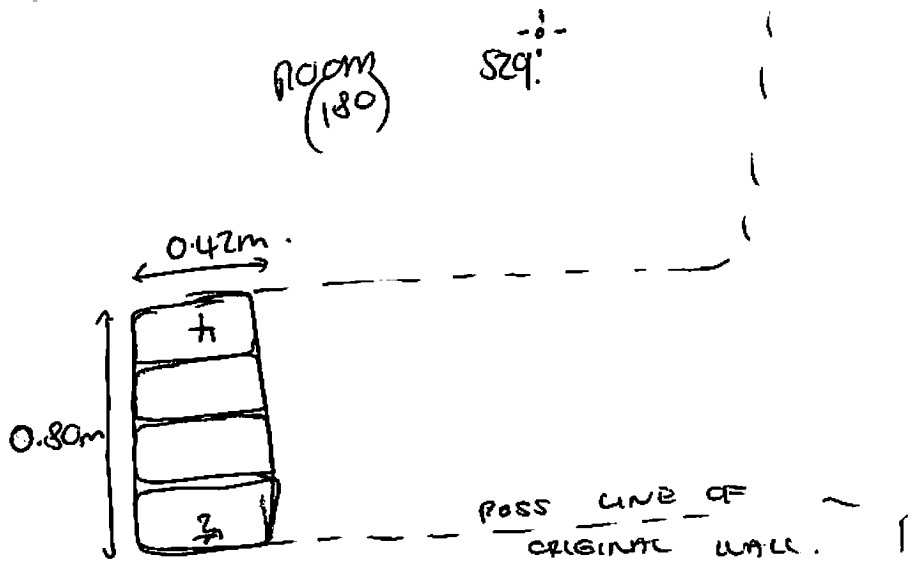
Context Same As:
 Drawing Nos: 2008.3

INTERPRETATION	Enclosing	Internal	External
Reason for decay	Possible E-W mudbrick wall fragment		
Indications of original dimensions			
Indications of original functions	Rep. - ACC TO HASSAN'S PLANS MAY REP. S. WALL OF ROOM # 180 / N. ENCLOSURE TO ROOM # 178.

Room (178)
