GPMP 2009 KKT-E	GRID SQUARE(S) 201. H35	ARCHITECTURE	CONTEXT 30856
1. Material	1. MUD BRICKS		
2. Size of materials	2. UNKNOWN		
3. Finish	3. —		
4. Coursing/bond	4. UNKNOWN		
5. Form	5. DOOR JAMB		
6. Direction of faces	6. W-E S		
7. Orientation	7. E-W		
8. Dimensions	8. max height: ca. 1.15m; F/W: BOTTOM = 1.11m; TOP = 1.15m width: 0.21m		
9. Associated collapse	9. pos part of 29046; pos. 2 30857 → sheet fall ruined as a step (see: 30857)		
10. Founds. cuts & fills	10. —		
11. Repaired	11. unknown		
12. Associated floors	12. 30810, 30833/30840		
13. Plastered	13. 29058, 29059		
14. Wall core	14. —		
15. Types of brick (%)	15. mud bricks (some untempered clayey silt and other with sandy silt)		
16. Composition of bricks	16. see (15)		
17. Dimensions of bricks (sample of three)	17. unknown

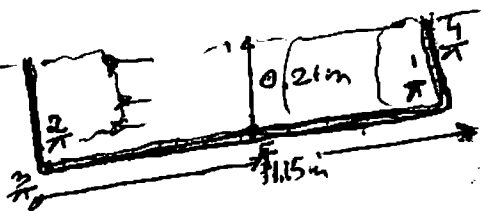
in plan

INTERPRETATION	Enclosing	Internal	External
Reason for decay	This feature is a clay jamb, contemporary with floor 30810, built on to wall 29057; its opposite is 30873		
Indications of original dimensions			
Indications of original functions			
EXPOSED, NOT EXCAVATED.
