Site: GPMP 09 Area: KKI-E	GRID SQUARE(S) 201. H36	ARCHITECTURE	FEATURE # 30886
1. Material	1. mud bricks &		
2. Size of materials	2. 30cm x 16.5cm x 8cm (there are pos. other sizes but these bricks are too damaged)

INTERPRETATION	Enclosing	Internal	External
Reason for decay	BADLY DAMAGED UPRIGHT PART OF THE BLOCKING		
Indications of original dimensions	FEATURE IN THE ENTRANCE BETWEEN 29068 and 29062		
Indications of original functions	It has not been excavated, just exposed		
partially; its surface side has plaster on it (cannot) 30881			
→ plaster is plaster belongs to 29062 as we haven't			
excavated the E limit of 30886; bricks of 30885			
rested on top of it; E limit of 30886 - not exposed

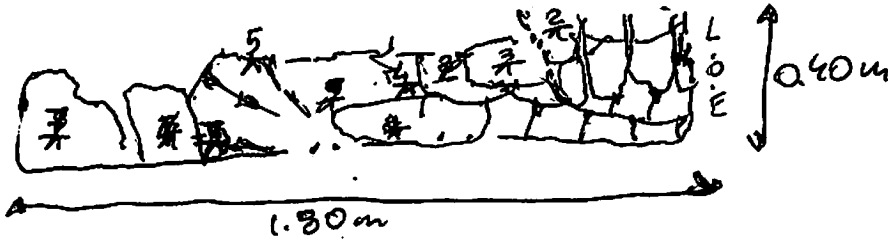
Sketch Plan - Include grid co-ordinates, North arrow, and elevations.

Top 17.70
PS 3.23
14 20.93

- 1) 2.82 18.11
- 2) 2.83 18.10
- 3) 3.17 17.76
- 4) 3.23 17.70
- 5) 2.98 17.95
- 6) 2.92 18.01
- 7) 2.76 18.17

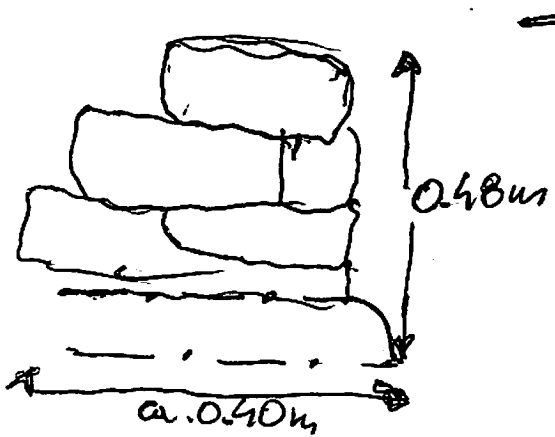
Profile Sketch

see also sketch on the back of ARCHITECTURE SHEET for 30886 (to which 30881 is bonded)
