GPMP 2009	GRID SQUARE(S) 101 - P23	ARCHITECTURE	CONTEXT 30941
------------------	-----------------------------	--------------	------------------

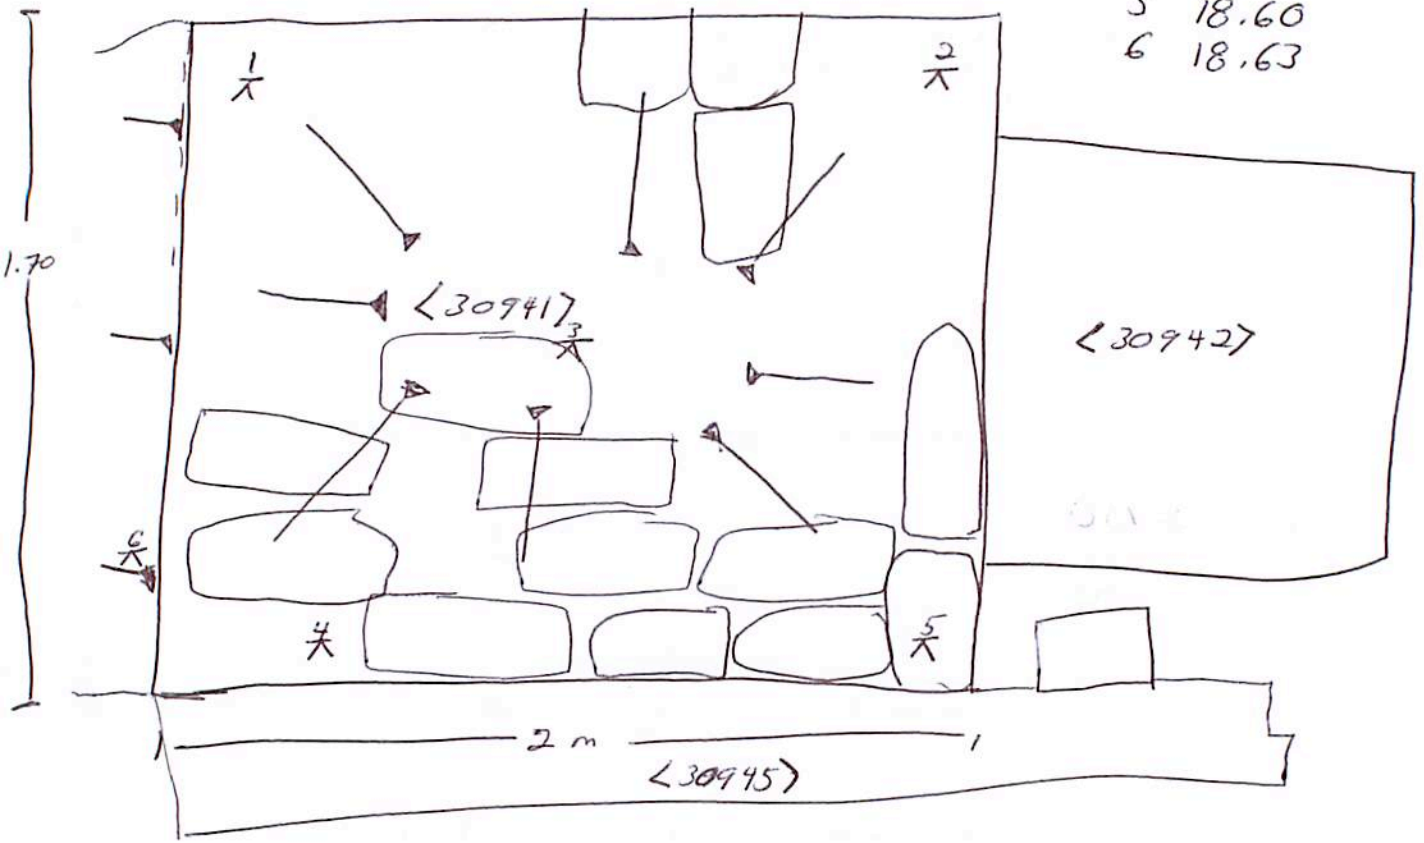
1. Material	1, mud brick
2. Size of materials	2, -
3. Finish	3, -
4. Coursing/bond	4, 10 rows of headers, with stretchers along the front
5. Form	5, podium top
6. Direction of faces	6, ←
7. Orientation	7, N-S/E-W, rectangle depends on approach
8. Dimensions	8, 2.00 x 1.70 x ≈ 0.37 meters
9. Associated collapse	9, -
10. Founds, cuts & fills	10, -
11. Repaired	11, -
12. Associated floors	12, -
13. Plastered	13, -
14. Wall core	14, mud brick
15. Types of brick (%)	15, Nile silt large (i.e. royal) bricks
16. Composition of bricks	16, Nile silt
17. Dimensions of bricks (sample of three)	17, 40 x 20 x ? cm

X	
1	18.50
2	18.58
3	18.70
4	18.59
5	18.60
6	18.63
