AREA: KKT-N	GRID SQUARE (S): 201 E15,16	GRID CO-ORDINATES: E N	INITIALS & DATE: EMS 23/2012	FEATURE No.: 33321															
FEATURE TYPE (For example wall, staircase, bench, foundation structure, platform etc.): wall			Full extent visible in plan: <input checked="" type="radio"/> YES / NO																
1. Dimensions (in metres)		Length: 2.7 m	Width: 0.6 m	Height: 0.12 m															
2. Type of material(s) used		mudbrick (w/ clay)																	
3. Coursing (form of construction)		irregular																	
4. Orientation		E-W																	
5. Associated collapse		-																	
6. Cut & fill feature #'s		-																	
7. Repaired?		-																	
8. Associated floors		-																	
9. Surface treatments? E.g. plaster, paint, mouldings		plastered on both sides																	
10. Size of one component		0.4 by 0.2 m by 0.1 m																	
11. Bonding material		sandy silt																	
12. Excavated		Yes/No NOT EXCAVATED																	
Mini stratigraphic matrix

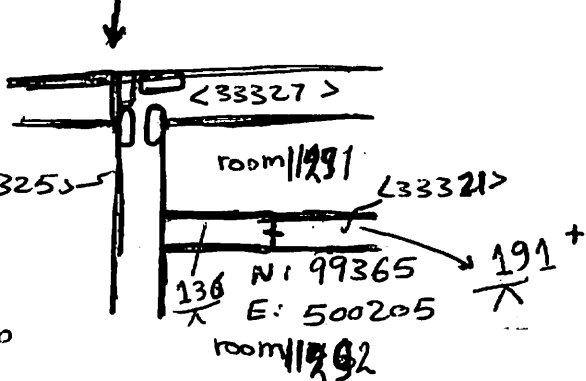
Sketch Plan - Include grid co-ordinates, North arrow, and elevations.

33290	33307					33321						33325		Abuts: 33325 Same as: Abutted by: Associated features: Bonded into: 33298 Contiguous with:		
	33290	33307																	
	33321																		
	33325																		
Discussion and interpretation: <p>E-W mudbrick wall formed the southern border of room 47 and the Northern border of room 11292, it is bonded into N-S wall 33298</p>

the western limit of house C

$\frac{191}{\times}$ 1.45 25.45
 $\frac{136}{\times}$ 1.22 25.54
