AREA: GRID SQUAR		RES:		INITIALS & DATE:		FEATURE No.:
KKT-E+	201-446			HMM 27II 2014		33437
FEATURE TYPE (For	staircase,	e, bench, foundation Full extent visible in pl		alan:		
structure, platform et	YES / NO		NO

ARCHITECTURE RECORDING FORM

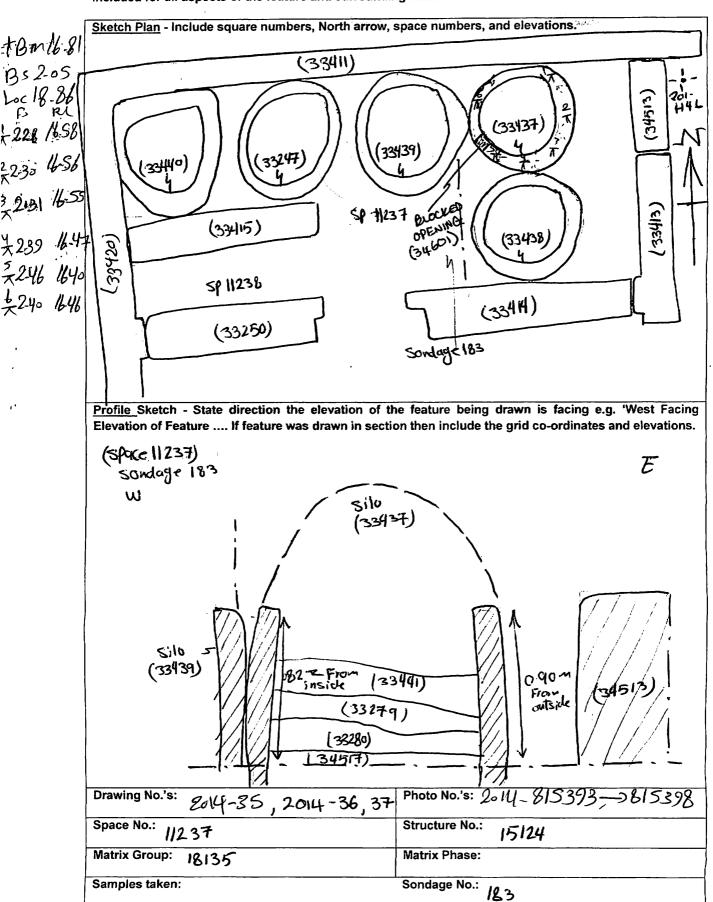
1. Dimensions (in metres)		Lengths diancter 1-46mm Brend dianeter 1-46mm			Height:	
2. Type of material(s) used		mark Brick				
3. Coursing (form of construction)		n stretcher Courses only seen

9. Surface treatments? E.g.		mud Render (34519)				
plaster, paint, mouldings						
10. Size of one component		0.28 m 10.14 m 10.08 m				
11. Bonding material		slightly Asky Silt with v small limestone frags

12. Excavated		Yes(No)				
Mini stratigraphic mat		Abuts: Same as:				
34519 3460		4	Abutted by:	Associated features:		
3343	Bonded into:					
ME		Contiguous with:				
Discussion and interpretation:						
NE Circular silu Located in the most eastern Corner of space						
11237 (516 space) to the North of DE 310 (55138) who is						
the east of (33439). The SE External character side of site of						
Very Thin There is Crack Visible In Mass Sive The Silo Will						
Querical a midually lawards the inside so was paulied or						
domed shaped top cauld be reconstructed. We didn't Expose						
The bottom of this silo.						
V
