| AREA:<br>KKT-E+ | GRID SQUARES: 201-J41, 201-J43<br>201-J42, 201-J44, 201-J45<br>201-K44, 201-K45, 201-K46, K47 | INITIALS & DATE:<br>DCJ<br>19 APRIL 2014 | FEATURE No.:<br>33452 |
| FEATURE TYPE (For example wall, staircase, bench, foundation structure, platform etc.):<br>WALL. | | Full extent visible in plan:<br>YES / (NO) | |

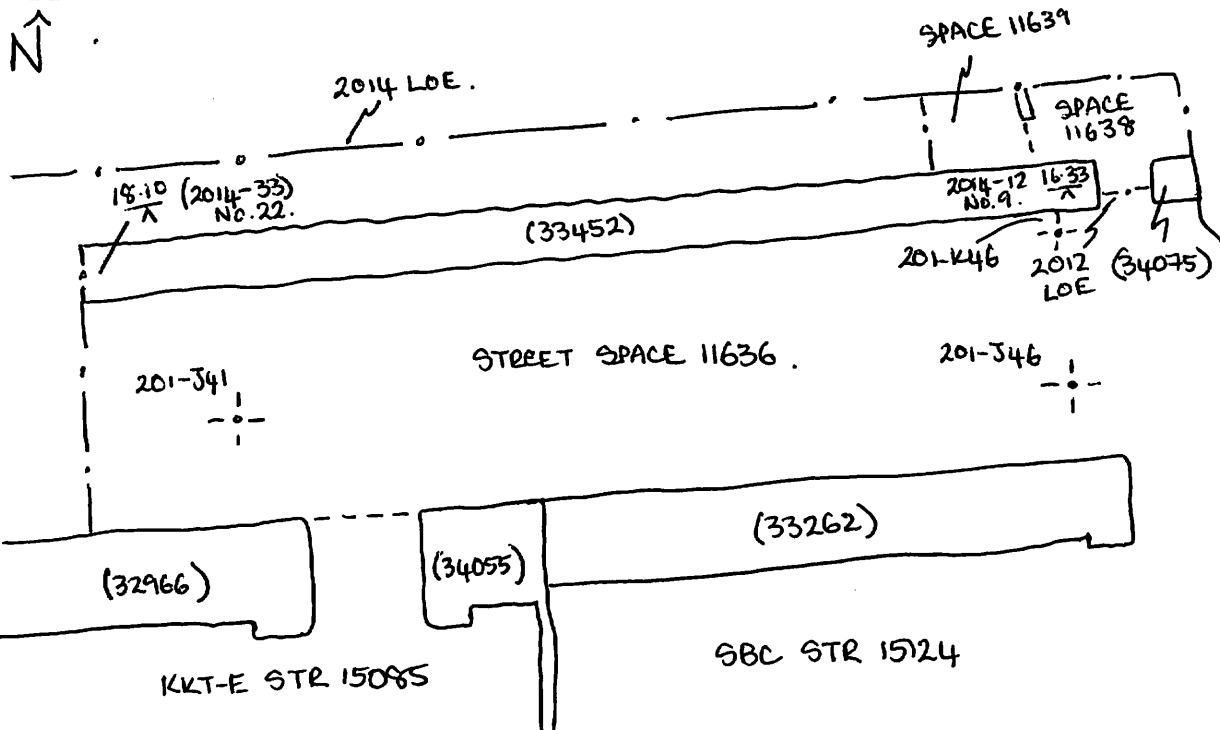
**Sketch Plan** - Include square numbers, North arrow, space numbers, and elevations.

| Discussion and interpretation:<br><br>EXTENSIVE LIMESTONE WALL BORDERING THE NORTHERN SIDE OF BROAD STREET SPACE 11636. EASTERN LIMIT FUNCTIONS WITH THE WESTERN LIMIT OF LIMESTONE WALL (34075) FORMING AN OPENING TO SPACE 11638 TO THE NORTH. PARTIALLY EXPOSED IN 2012. FURTHER EXPOSED IN 2014. WESTERN LIMIT UNKNOWN AS STILL LOCKED UNDER CRUSHED LIMESTONE DEPOSITS FROM THE NORTH. | | | |

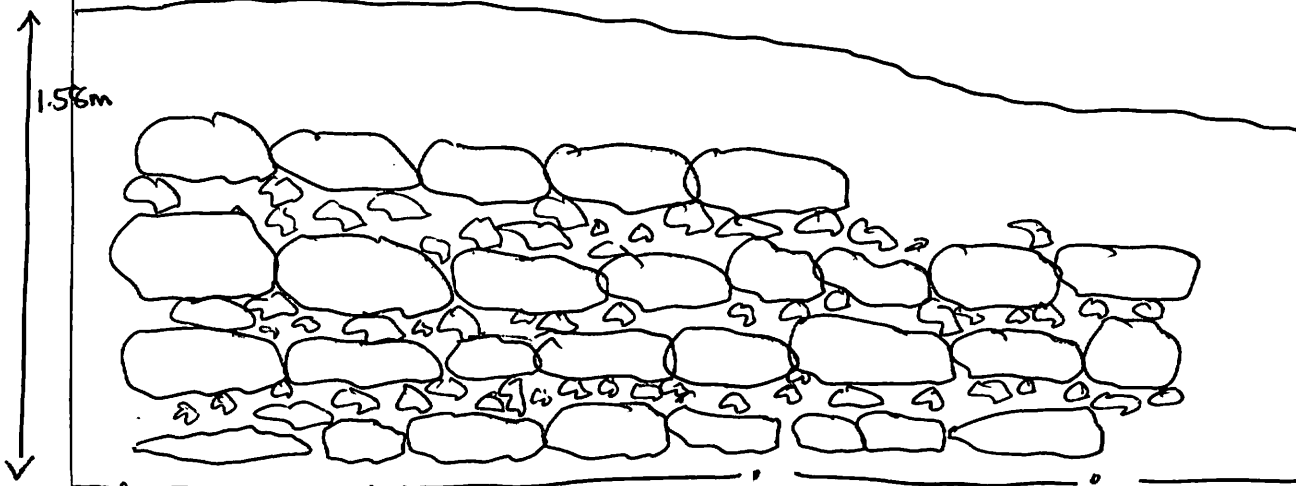
**Profile Sketch** - State direction the elevation of the feature being drawn is facing e.g. 'West Facing Elevation of Feature .... If feature was drawn in section then include the grid co-ordinates and elevations.

| 3. Coursing (form of construction) | FAIRLY REGULAR COURSES OF LARGE STONES, WEDGED / HELD IN PLACE WITH SMALLER STONES. 4 COURSES CAN BE SEEN IN PHOTO 815416. | | |
| 9. Surface treatments? E.g. plaster, paint, mouldings | MUDRENDER (34545) } NORTH & EAST FACING<br>MARL PLASTER (34039) } ELEVATIONS. | | |
