AREA: Kkt-N	GRID SQUARE (S): 201 C 15-13	GRID CO-ORDINATES: E N	INITIALS & DATE: SAER 1 ii 2012	FEATURE No.: 33467
----------------	---------------------------------	------------------------------	---------------------------------------	-----------------------

FEATURE TYPE (For example <u>wall</u> ) staircase, bench, foundation structure, platform etc.): wall	Full extent visible in plan: <input checked="" type="radio"/> YES / NO
---	---

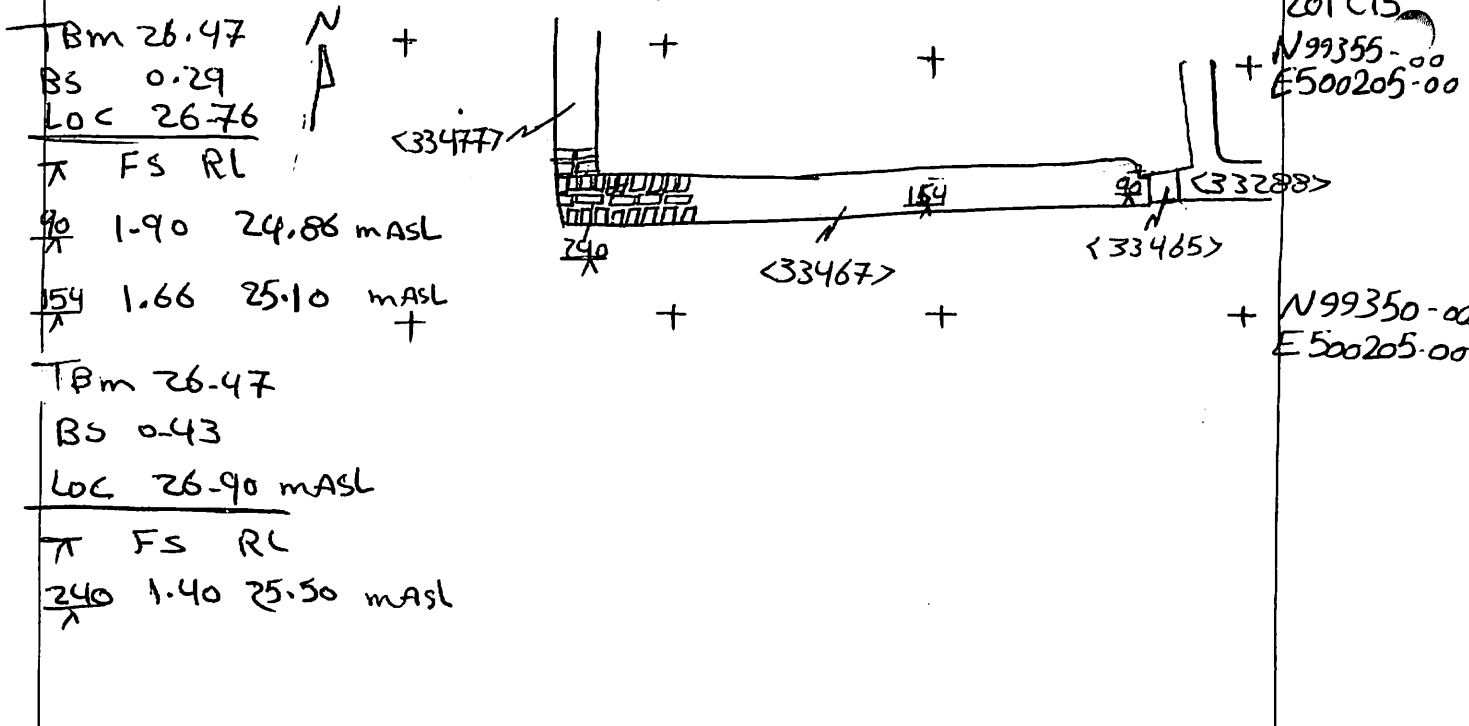
Sketch Plan - Include grid co-ordinates, North arrow, and elevations.

1. Dimensions (in metres)	Length: 10.20 m	Width: 1.05 m	Height: 0.15 m
2. Type of material(s) used	mud brick		
3. Coursing (form of construction)	3 courses		
4. Orientation	E-W		
5. Associated collapse	-		
6. Cut & fill feature #'s	-		
7. Repaired?	-		
8. Associated floors	-		
9. Surface treatments? E.g. <u>plaster</u> , paint, mouldings	33285, 33504, 33503		
10. Size of one component	0.40 m x 0.20 m		
11. Bonding material	sandy silt		
12. Excavated	Yes <input checked="" type="radio"/> No <input type="radio"/> Not excavated

Discussion and interpretation:  
 E-W mud brick wall formed the south boundary of house (B).  
 it is consist of two headers at the outline of the wall and between them one row strecher. it coated by two crushed tafla plaster, earlstone (33504) and (33285).  
 the wall itself formed the southern boundary of spaces. From the Southern face. (11299), (11304), (11305)  
 it coated by crushed tafla plaster ~~33503~~ (33503) from the northern face.
