AREA:	GRID SQUARE (S):	I	RDINATES:	· 	INITIALS & DA	ΓE:	FEATURE No.:	
KKt-N	201 D14 201 E14	N E		MFMH 1-2-2012		33472		
FEATURE T	YPE (For example wa	II) staircase,	bench, found	ation	Full extent visil	ole in p	lan:	
structure, p	elatform etc.):	all			(YI		NO

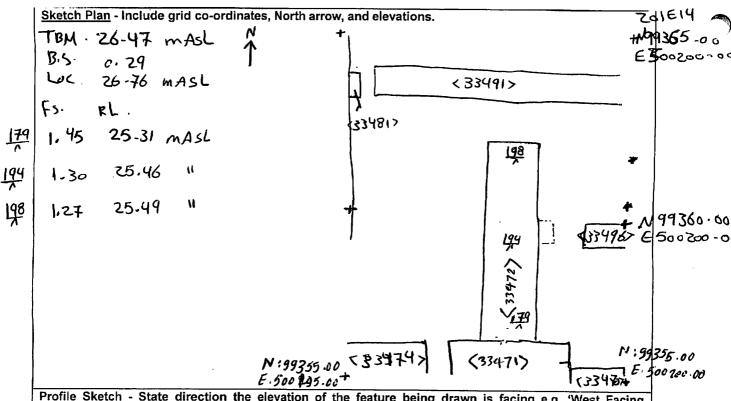
11. Bonding	material	Sand	19 Silt			•		
12. Excavate	ed	Yes(No	Not 6	* Cal	vated			
Mini stratigr	aphic matrix		Abuts: <33	471	Same a	s:		
			Abutted by:		Associa	ated fea	ntures:	
	33472		Bonded into) :				
	33471		Contiguous with:					
Discussion a	and interpretation:		<u> </u>					
it's au	rall of mulbric	k (N-S), it con	sists	of Two coun	ses,	the western	
face is	headers, and the	in the e	astern on	e is s	itrechers. H	meas	sives

5.35 m	length by 0.60	m width	· It ab	uts +	he wall <	3347	7# >.	
forms +	the western he eastern wee	wan g le of th	e space	(113	11301 , 1136 1 03) .	2) an	d the It	
it is clear	My that thewal	Uis in o	e bad Ends	tion	because son	e pa	its are	
traded an	ed the crushed	line ston	e appears	frequ	ently_
