AREA: KKT.N	GRID SQUARE (S): 20F11	GRID CO-ORDINATES: E N	INITIALS & DATE: MFMH 25.11.2012	FEATURE No.: 33534
-----------------------	----------------------------------	------------------------------	--	------------------------------

FEATURE TYPE (For example wall, staircase, bench, foundation structure, platform etc.): door jamb	Full extent visible in plan: <input checked="" type="radio"/> YES / NO
---	---

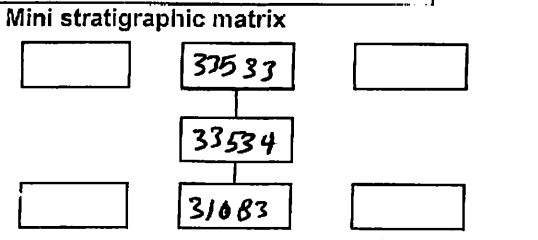
1. Dimensions (in metres)	Length: 0.60m	Width: 0.15m	Height: 0.15m
2. Type of material(s) used	mudbrick		
3. Coursing (form of construction)	one course		
4. Orientation	E-W		
5. Associated collapse	—		
6. Cut & fill feature #'s	—		
7. Repaired?	—		
8. Associated floors	—		
9. Surface treatments? E.g. plaster, paint, mouldings	—		
10. Size of one component	0.40m by 0.20m		
11. Bonding material	Sandy silt		
12. Excavated	Yes/No <input checked="" type="radio"/> No

it is a mudbrick door jamb (E-W), it measures 0.60m by 0.15m. It consists of one course, it abuts the northern enclosure wall **<31083>** and is abuted by a threshold **<33533>**. It seems to be a modified event, where as a plaster layer is laying between them. It forms the central northern-west entrance at the northern street.
