AREA:	GRID SQUARE (S):	GRID CO	ORDINATES:		INITIALS & DA	TF:	FEATURE No.:
l	201011	E			HAHA AF		
KK7- N	201 DII	N			22 ii 2018		33785
FEATURE T	YPE (For example wa	II, staircase	e, bench, found	ation	Full extent visi		l plan:
structure, p	latform etc.):					ES)/	
1 Dimensio	ns (in metres)	911	-	146.44

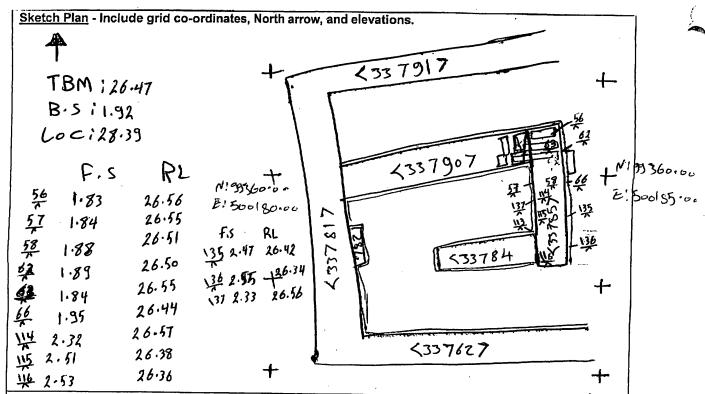
11. Bonding	material	30	ndy si	1+		•	
12. Excavate	d	Yes/No	Not	EXC	avated		
Mini stratigra	phic matrix	[Abuts: <33	7907 (337847 Same a	s:	
	73 784 33	790	Abutted by:		Associa	ited fea	itures:
	33785		Bonded into	:			
			Contiguous	with:			
Discussion a	nd interpretation:		-l				
wall < 3	33785> is ma	de of mu	ed brick . i	if is o	riantated f	rom /	N to s
This wal	ll is Coated by p	laster (337861.	the w	all is a bufe	ed by	two walls
く337	llis Coated by p 84> and < 33	790> 1	This wal	1 15+1	he eastern u	vell t	ospace
) an the western						
the Easterns	side strecher and	the west	ern side is	head	ser.		
							4 .
