AREA:	GRID SQUARES: 201- F44, 201-F45				INITIALS & DATE: FEATURE No.: (るものは)=		
KKT-E+	· · · · · · · · · · · · · · · · · · ·			10 MARCH 2014 (34064)		1	
FEATURE TYPE (For ex	staircase, bench, foundation		Full extent visib	le in p	lan:		
structure, platform etc.):			NG.		YES / NO

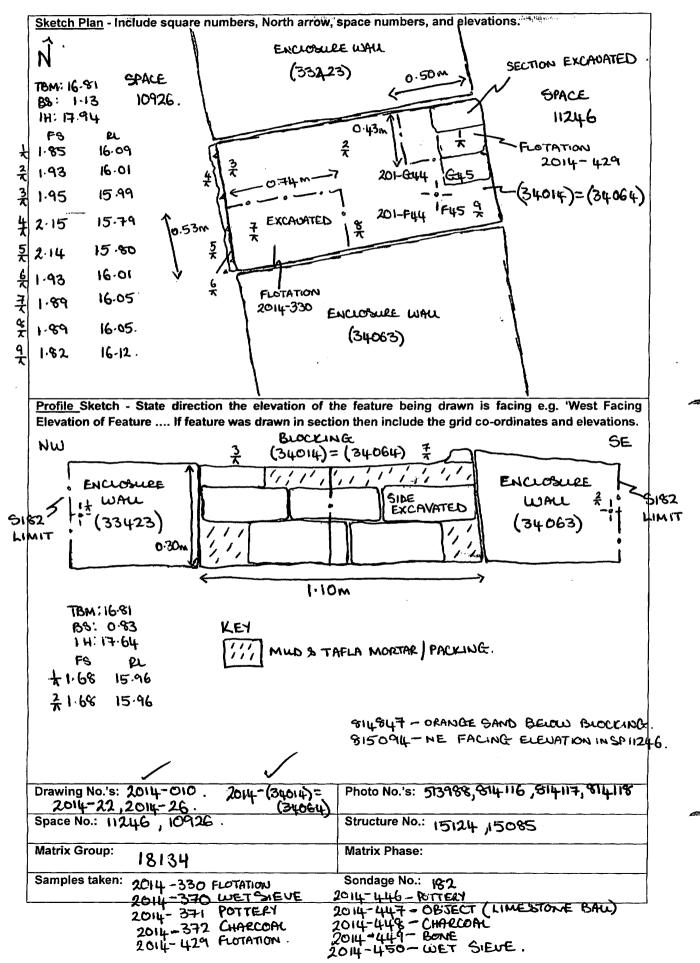
1. Dimensions (in metres)		Length: Width		: [	Height:		
		2.72 m			1.10m	0.30m.	
2. Type of material(s) used		SANDY MUDBRICK 100%					
3. Coursing (form of construction)		A courses HIGH BOTTON 2 COURSES STRETCHERS

4. Orientation		NE SW.					
5. Associated collapse		UNKNOWN BUT MAYBE (33240)					
6. Cut & fill feature #'s		NO CUT #					
7. Repaired?		NO REPARES UTSIBLE.

8. Associated floors		(34473), (34472), (34469), (34468) IN SPACE 11241 LEMDER (34495 WHITEWASH: (341					
9. Surface treatments?	· · · · · · · · · · · · · · · · · · ·						
plaster, paint, mouldings		SAME AS BECAUSE THESE LIPPED-UP ONTO THE SW FACING ELENATION OF THE BLOCKING.

10. Size of one component		0.38m(L) x ().11m(HIGH) x 0.19m (WIDE)					
11. Bonding material		MARL SALT MIXTURE .					
12. Excavated	(Yes'NO ONLY PARTIALLY - SEE OVERLEAF.						
Mini stratigraphic matri	Abuts: Same as:						
34478	Abutted by: Associated features:						
3404	Bonded into:						
34504	Contiguous with:						
Discussion and interpretation:							
			A		B. c	92.7	12)
BLOCKING IN ENCLOSUSE WALL OPENING BETWEEN (33423)							
<b>ў (34063)</b> .							
ONLY EXCAUA	TED IN	2 <b>s</b> ec	TIONS; O	ME 11	THE NE	3 o	NE
IN THE SW - SEE SKETCH OVERLEAF.
