Locus W9729	Dor 19 9.1	Fld G.	Sq ^{AW} 41.33	Loc. type Wall
Open	Date 05/08/91	High at 1.5.02 E	Low at 1.4.83 W	Seals: _____
Close	07/08/91	1.4.46 W	1.4.36 E	Sealed by: _____
Floor: type	_____	_____	_____	Loci 9096 9684 9723 9716
Length 3.5	Width 0.4	Vol. _____	Drawn? YES	above 9723 _____
Value 1	Remove 1/1/1	_____	_____	below _____
Photo #(1) _____	Photo #(2) _____	_____	_____	_____
Written by: RJS	Checked by: JRZ	_____	_____	_____

LOCUS
W 9729

Locus W9729	Dor 19 92	Fld G ₁	Sq A1/AH/33	Loc. type Wall Card 2
Open 14/07/92	High at 15.02 E	Low at 14.83 W	Seals: _____	
Close 14/08/92	High at 14.00 E	Low at 13.95 W	Sealed by: _____	
Floor: type _____	Length 3.5	Width 0.4	Vol _____	Locl _____
Value _____	Remove _____	Drawn? YES	above _____	
Photo # (1) See Isra	Photo # (2) _____	Locl _____		_____
Written by: RSS	Checked by: JRZ	below _____		_____

Locus W 9729	Dor 1913	Fld G1	Sq A H1/A133	Loc. type WALL CARD #3	entered
Open	Date 02/07/13	High at 15.02 E1	Low at 14.83 W1	Seals: _____	_____
Close	06/08/13	13.510 W1	13.49 E1	Sealed by: _____	_____
Floor: type	CF	_____	_____	Locl SEE PREVIOUS SEASONS CARDS	_____
Length 3.5	Width* 0.4	_____	Vol _____	above _____	_____
Value 1	Remove _____

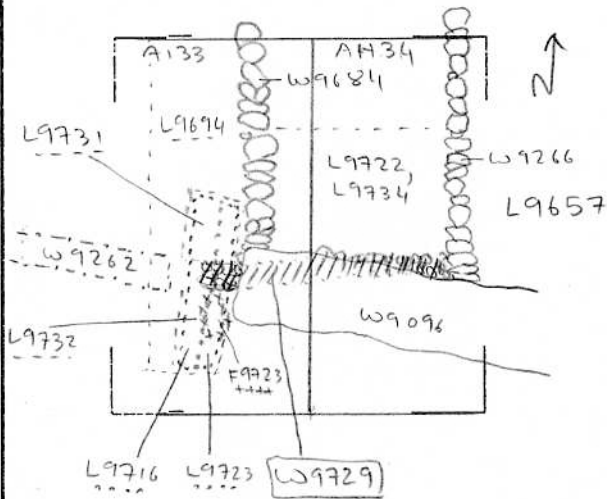
Sketch plan

Matrix: Mostly made of head or half-head size cobbles. Some fist-size cobbles. Not similar to any surrounding walls. So far 4 courses have been uncovered and the wall does not float.

Relations: L9716 and L9723 cover W. extension of W9729. L9722 covers E. extension of W9729. The wall appears to continue between these parts below W9096. W9684 covers a small area of W9729 W. of W.9096. To the N. L9731 and L9736 reach W9729. To the S., L9732 and probably the fill below W9096 reach W9729. To the W., L9694 reaches W9729. To the E. W9729 appears to abut W9266, and does not seem to dovetail, cut or be cut by W9266. It is possible the W9729 continued E. of W9266, the remnants of which are rubble in L9657. Where W9729 enters the fill below W9096, it dovetails with W9684 (which is perpendicular to it). F9723 to the S., sloped upwards to the upper course of W9729 and may have reached it. W9729 is on a direct line with W9262, to the W., a mud-brick wall sitting on a stone socket. It is possible that W9729 is either built on top of W9262 or that W9262 is an E. continuation of W9729, and in fact reaches W9729. It is currently too difficult to determine. It is not at all clear why W9729 ends on a flat W. face; there is no evidence for a robber trench nearby.

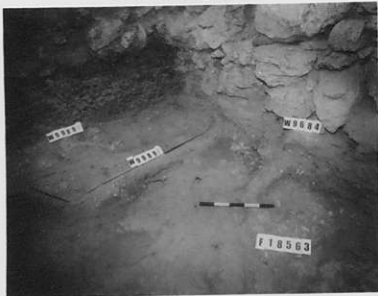
Photos 192860 + 192865 show a W9989. This is incorrect (W9989 is E. of W9864). On L18563 this mudbrick material is recorded as W9729b, apparently a mudbrick phase below the field stone phase of W9729a

W9989 = W9729b
