Locus W 9804	Dor 19 9,2	Fld G ₁	Sq AI 32	Loc. type wall / balustrade
Open	Date 28/07/92	High at 1.3.4.6 S ₁	Low at 1.2.9.2 N ₁	Seals: none yet
Close	14/08/92	1.2.6.7 W ₁	1.2.5.3 E ₁	Sealed by:
Floor: type				Locl 9765 9779
Length 2.2	Width 0.2	Vol	Drawn? YFS	above
Value 4	Remove			below
Photo #(1) 86648	Photo #(2) 86645			
Written by: RAI	Checked by: JRZ

Summary

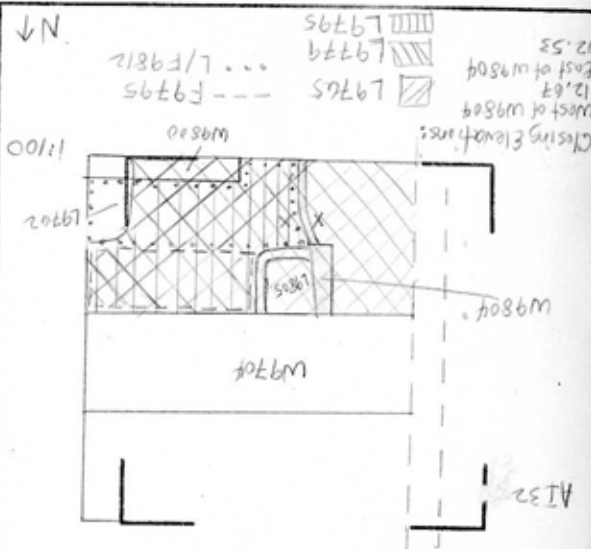
Sketch plan

Matrix: Elliptical-shaped ^{or curved} structure, apparently of limestone, enclosing ^{burnt} mudbricks (3-4 courses thus far exposed or extant) within parallel vertical slabs, apparently, of limestone — slab preserved mainly on eastern flank of structure; structure appears to have been covered in plaster or maybe mudbrick as a finish; elliptical stone preserved only at Northern end (see drawing reverse)

*Matrix (continued): The slab preserved on the East is conjectured to have its match on the West, enclosing mudbricks in between. To the West, however, the slab is not preserved. The elliptical stone is also not preserved to the South, but is conjectured.

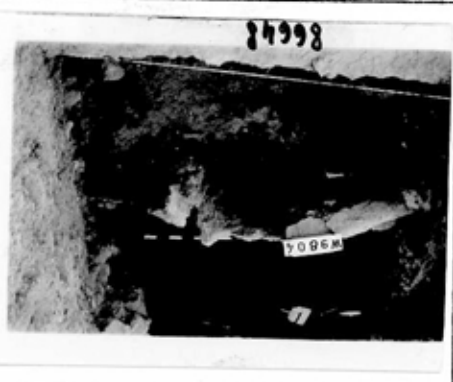
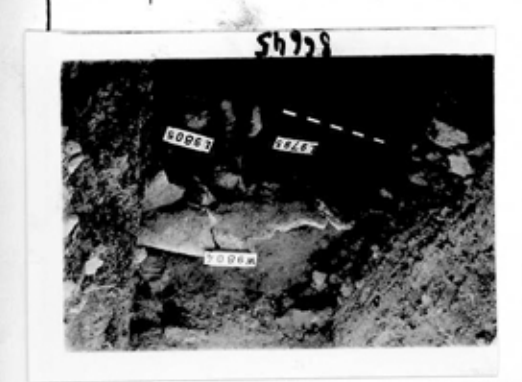
Plaster/mud brick (?) stable wall. Ma-stone (?)
