AREA:	GRID SQUARE (S):	GRID CO-ORDINATES:	INITIALS & DATE:	FEATURE No.:
AKT-E	201.H36 201.H37	E N	KW 9/02/2011	32929

FEATURE TYPE (For example wall, staircase, bench, foundation structure, platform etc.):	Full extent visible in plan: YES / <b>(NO)</b>
WALL (RETAINING)

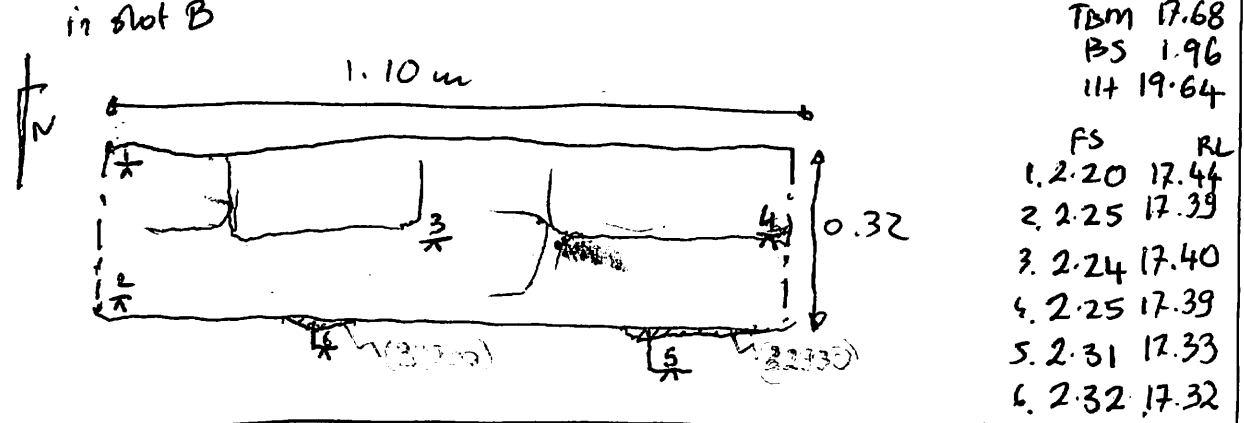
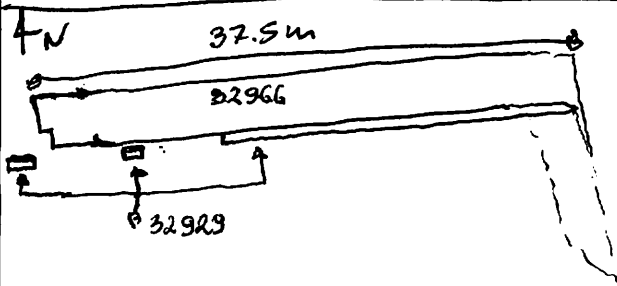
**Sketch Plan** - Include grid co-ordinates, North arrow, and elevations.

This wall has been observed in plan along 32966, right to the place where it turns south; it possibly stretched from east to the bedrock in the W and would measure c. 4.5m; observed also in slot "A" in 2009.

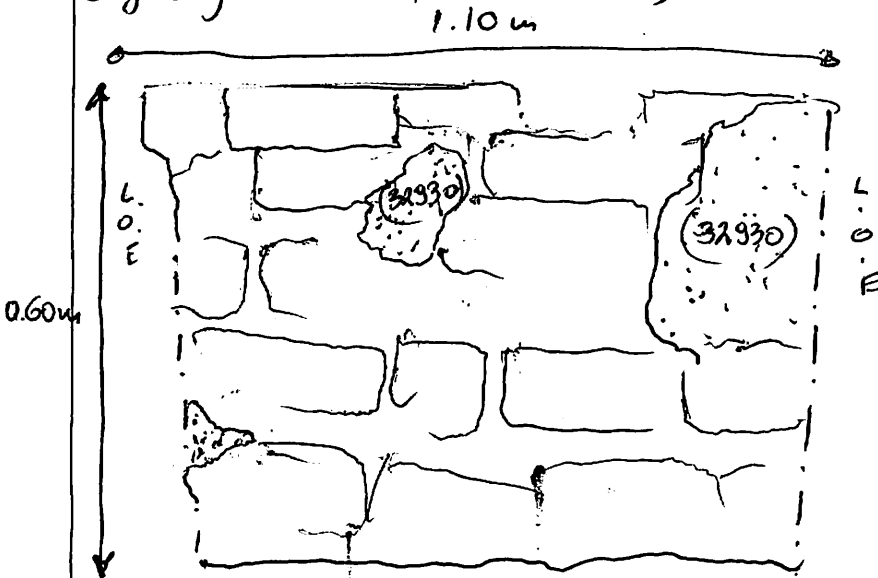
5-facing elevation (Slot B)

Bottom course of mudbricks is much more carefully laid out → stretchers on their beds, x 0.16m large silty bricks (v. 0.40m long x v. 0.20m wide). Spaces in between the bricks filled with silt (contains charcoal and pottery); some brick seen reversed and were most probably on them.
