GPMP 2008	GRID SQUARE(S) 101.X30-X31	ARCHITECTURE	CONTEXT 21902
1. Material	1. Mud		
2. Size of materials	2. 37cm to 40cm x 17cm to 19cm		
3. Finish	3. Regular courses		
4. Coursing/bond	4. the western side is stretcher / the eastern side have one row stretcher 20cm x 40cm / and 2 rows header 30cm x 15cm		
5. Form	5. wall		
6. Direction of faces	6. North-South		
7. Orientation	7. East-West		
8. Dimensions	8. 98cm to 65cm wide x 5.00m long		
9. Associated collapse	9. N/A		
10. Founds, cuts & fills	10. N/A 11. N/A		
11. Repaired	12. N/A 13. N/A there is a plaster in Eastern and Western faces		
12. Associated floors	14. N/A		
13. Plastered	15. Sandy mud bricks		
14. Wall core	16. Mud + Sand + ocean ceramics and V. acca Lime Stone pebbles		
15. Types of brick (%)	17. See above		
16. Composition of bricks			
17. Dimensions of bricks (sample of three)

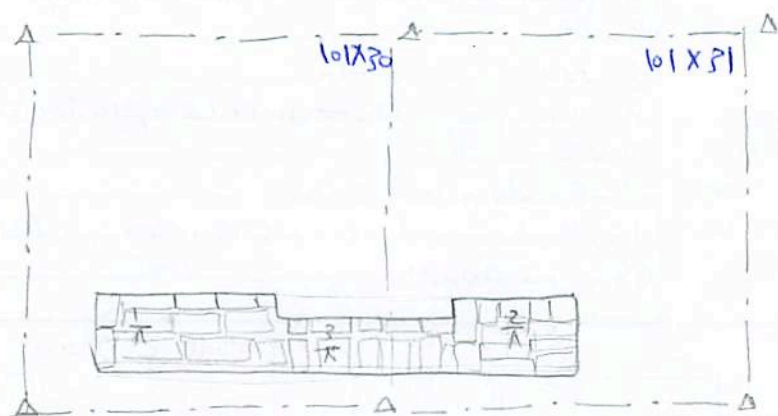
F# 21902

T.B.M:- 18.54
 B.S :- 2.58
 L.O.C: 21.12

π	RL
1- 2.98	18.14
2- 3.15	17.97
3- 3.13	17.99
