| | Site: GPMP 3 | | QUARE(S) | ARCHITECTU | RE FE | ATURE | |
| l l | Area: KKT | 70 201 | - B20 | | | 31882 | |

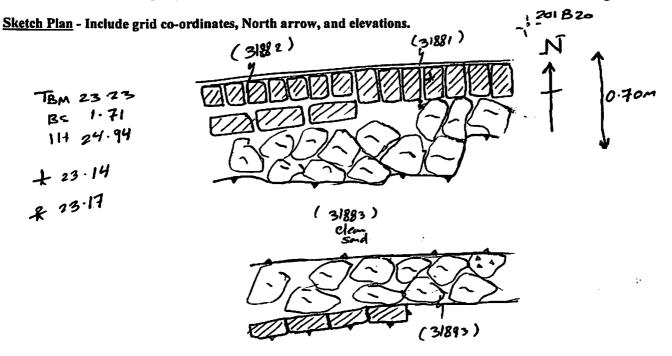
Sketch Drawings (in plan and in profile)

| | Site: GPMP 3 | | QUARE(S) | ARCHITECTU | RE FE | ATURE | |
|---|---|---|--|---|---|---|--|
| ľ | 1. Material | 1- Lin | 1- LimesTone + mud Brick | | | | |
| • | 2. Size of material 3. Finish | 2. 170 | 7. Hoomm X Foomm X From for the med Brick | | | | |
| | 4. Coursing/bond | _330 | 3300 mm x 1600 m x 2000 at for the limestone | | | | |
| ~ 1 | 6. Direction of faces 7. Orientation 4. Two Course herders + stretcher for the and Brick | | | | | | |
| f | 11. Repaired | J.rep | 5. repaired to the Southern enclosure well | | | | |
| Ī | 14. Wall core 8. 0. 70m (N-5) x 5.00m (E-W) x 6.40m deep | | | | | | |
