AREA:	GRID SQUARE (S):					FEATURE No.:	
MVT-E	101-020 101-021	N			HMM 28I201	2 -	<32 77 2>
	YPE (For example wa	II, staircase,	bench, found	lation	Full extent visi	ble in p	lan:
structure, platform etc.): Foundation Structure (Core Block) YES / NO

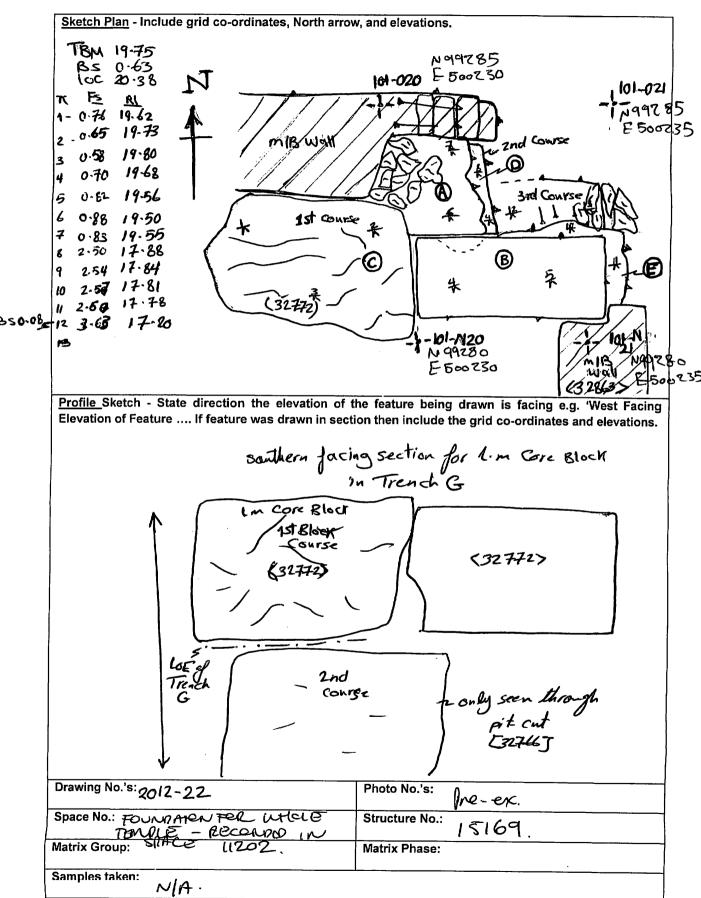
1. Dimensions (in metres) Length: Width: Height: 3.95 M (N-S) 3.95 M						1t: 15 M	
2. Type of material(s) used 2. Limestone							
3. Coursing (form of construction) & Three Courses of limestone Core Block

12. Excavate	ed	Yes/No	No				
Mini stratigraphic matrix Abuts: Same as: <29804>							
Abutted by: Associated features:						atures:	
3 2 772 = Bonded into:							
Contiguous with:							
Discussion and interpretation:							
-Three	-Three Courses of limestone Core Block, Limestone foundation						
-Three Conrses of limestone Core Block, limestone foundation dates to Henkunve Time, The Three Conrses only visible							
In NE Corner of the temple,							
Blocks 330m (EW) X 2.88 a (N=5) K 10 Light (Roughly huen)

* 3 30m (E-W) X 2.88 n (N-S) X 1.10m height (Roughly huen) - Some of this Stones are nickly worked and some are Roughly hwen.							
Roughly hwen.							
UPPER BLEWHEN: TOP COURSE: 19.73 m ASC.							
2ND COLETE & 17-88M ASC.							
BRA COLERO : 17-70m ARC.							
İ		J,					Alot
			——, t		and w		,~~
