AREA: MVT-E	GRID SQUARE (S): 101-K24 101-J24	GRID CO-ORDINATES: E N	INITIALS & DATE: JED 9-11-2011	FEATURE No.: 32798 32807
FEATURE TYPE (For example wall, staircase, bench, foundation structure, platform etc.): Buttress			Full extent visible in plan: YES / NO

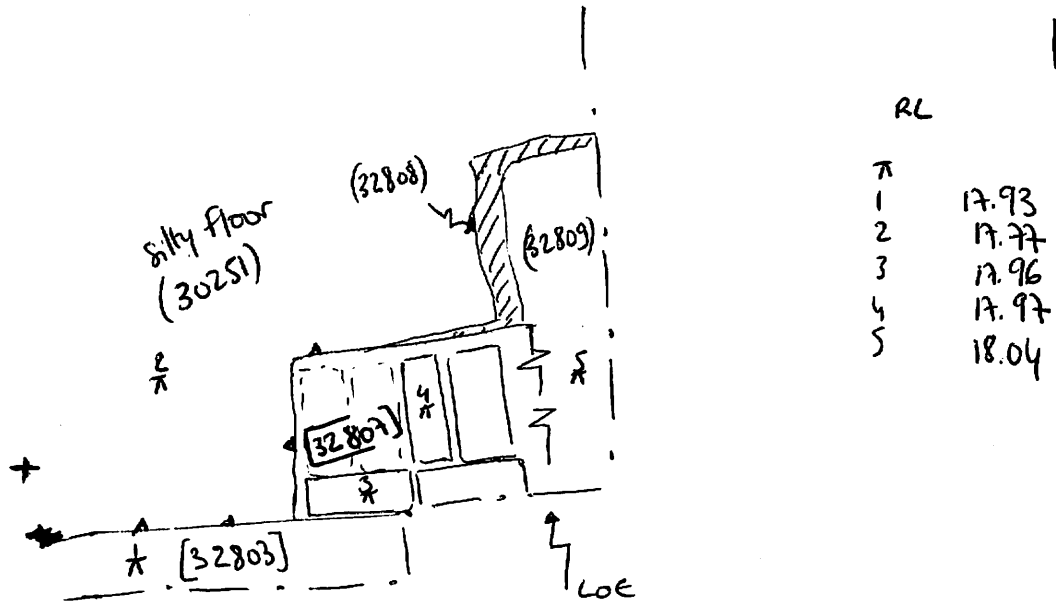
Sketch Plan - Include grid co-ordinates, North arrow, and elevations.

1. Dimensions (in metres)	Length: 0,91 m	Width: 0,66 m.	Height: 0,20 m.	
2. Type of material(s) used	Mudbricks.			
3. Coursing (form of construction)

10. Size of one component	21 x 42 cm.			
11. Bonding material				
12. Excavated	Yes /No			
Mini stratigraphic matrix 		Abuts: 32803 32809? Abutted by: Bonded into: Contiguous with:		
		Same as: Associated features: 32808		
Discussion and interpretation: Buttress in the SE corner of the courtyard. It abuts apparently the mb. wall [32803] and maybe the wall [32809] but it remains unexcavated. Lined with yellow plaster (32808).
