AREA: <i>MVT-E</i>	GRID SQUARE (S): <i>K21,22</i> <i>J21,22</i>	GRID CO-ORDINATES: <i>E</i> <i>N</i>	INITIALS & DATE: <i>REM, MAR</i> <i>HMM/27/02</i>	FEATURE No.: <i>32907</i>
FEATURE TYPE (For example wall, staircase, bench, foundation structure, platform etc.): <i>wall</i>			Full extent visible in plan: <b>YES / NO</b> <input checked="" type="radio"/>

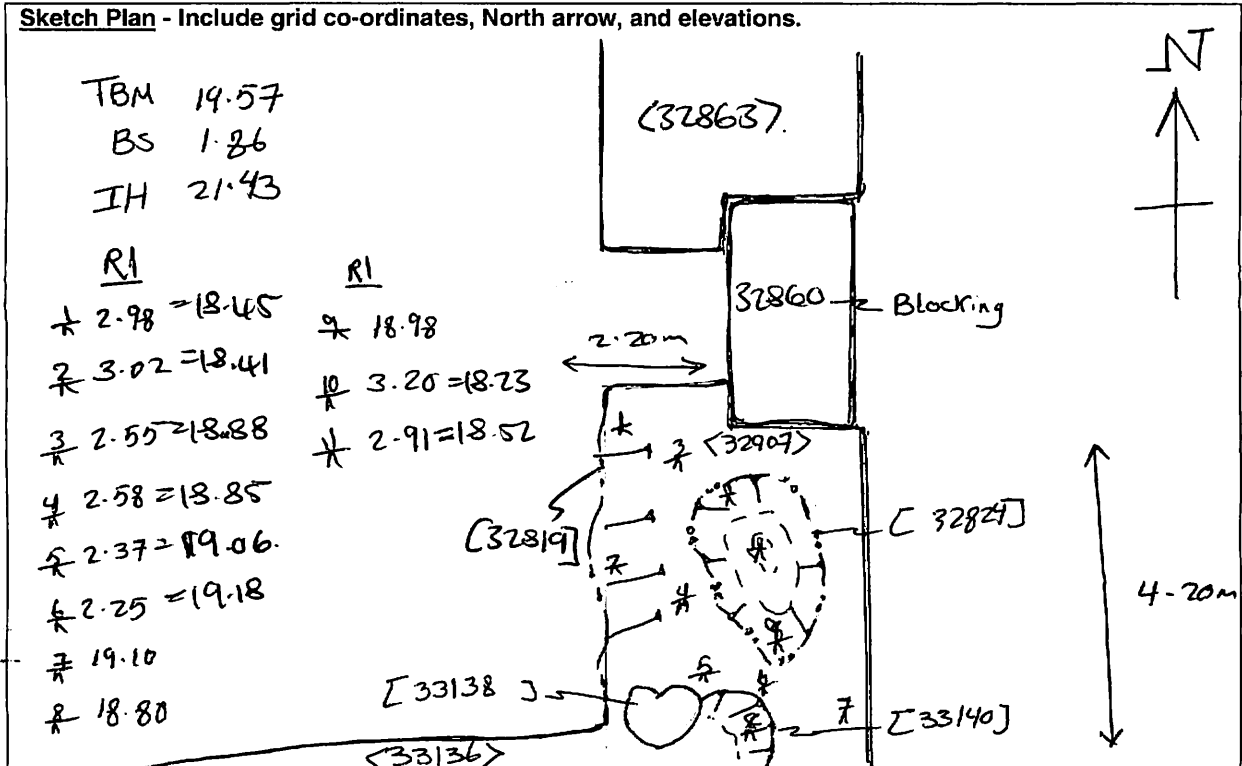
12. Excavated		<b>Yes/No</b> <input checked="" type="radio"/>		
Mini stratigraphic matrix		Abuts: <b>Same as:</b>		
<pre> graph TD     A["(32907)"] --- B["(32866)"]     B --- C["(33136)"]     </pre>		Abuted by: <i>32860</i>		
		Bonded into:		
		Contiguous with: <i>32863, 33136.</i>		
Discussion and interpretation:				
<p><i>massive mud brick wall, it located at the southern end of the excavation area 'MVT-E'. it appeared to be a massive door jamb of the vestruiken tranche before the blocked wall which happened in later time</i></p> <p><i>COUNTERPART TO (32863) - ROSS ABUTTED BY (33136) BUT HEAVILY TRUNCATED.</i></p> <p><i>ROSS DEGRADED REMAINS OF BUTTBESS TO W. (NOT QUON SOP-REARLS #)</i></p>
