2 1.1.0			IDIII ONI	
AREA:	GRID SQUARE (S):		ORDINATES: 310.000	•	INITIALS & DA	TE:	FEATURE No.:	
KKT-E.	201-036	N 993	60.000		DCJ 23/0	2/11	32979	
		staircase,	staircase, bench, foundation Fu			Full extent visible in plan:		
structure, p	latform etc.):					YES / NO

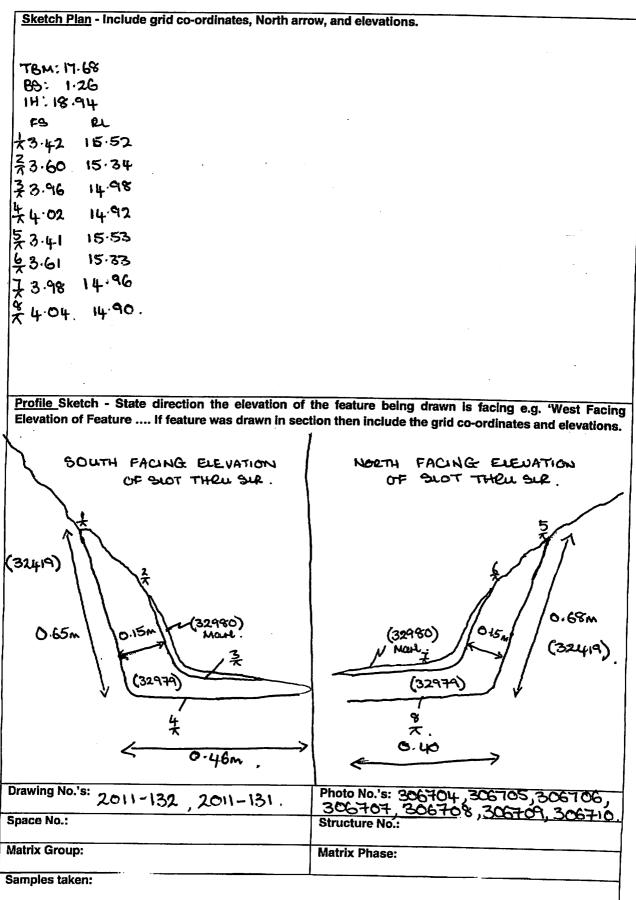
11. Bonding material		NONE	NONE UIBIBLE					
12. Excavate	d	Yes No						
Mini stratigraphic matrix			Abuts:			Same as:		
	32980.		Abutted by:			Associated features: (32980)		
	32979		Bonded into:					
	32419		Contiguous with: (32419)					
Discussion and interpretation:								
ONLY UTSIBLE IN SOUTH & NORTH FACING SECTION								
OF SLOT THROUGH SLR								
MUDBLICK ENCASEMENT WALL SLOPING UP FROM								
EAST TO WEST, ENCASING FOUNDATION DEPOSIT (32419)
