AREA:	GRID SQUARE (S):	GRID CO-	ORDINATES:		INITIALS & DA	TE:	FEATURE No.:	
	201-C36	E					· = · · · · · · · · · · · · · · · · ·	
KKT-E	1201-035,086 201-E35,E36	N			DCJ 23/0	D2/11	32981	
FEATURE T	YPE (For example wal) staircase,	bench, found	lation	Full extent visi	ble in p	lan:	
structure	latform etc.):	•				-		
	way & Fou			YES / (NO)

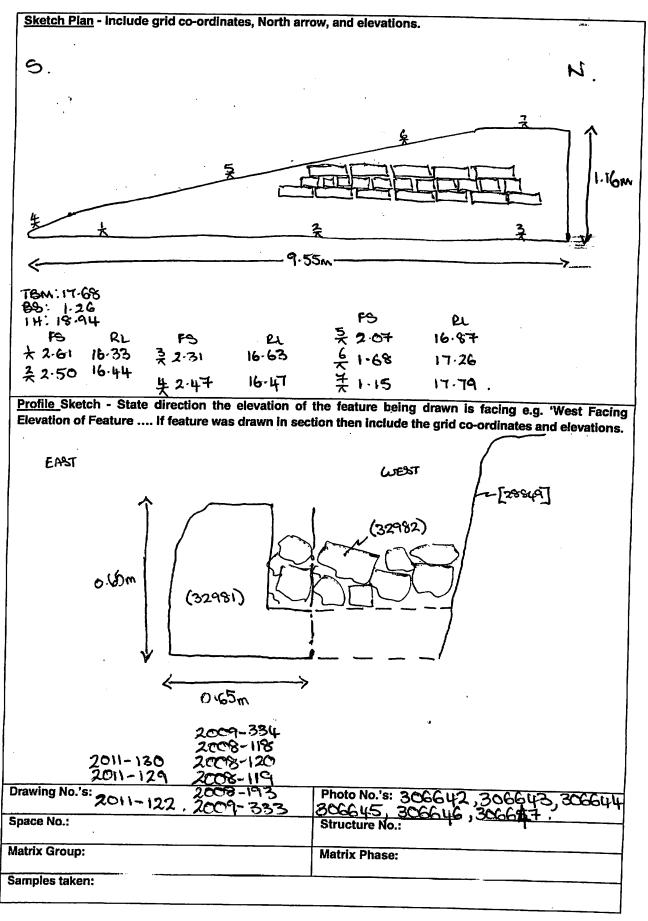
1. Dimensions (in metres)		Length	Length: 9.55 _M Width					
		4-5	20m ,	2	·34m.		1.16m	
	naterial(s) used		Mus Beick 100%.					
	(form of construction)	HEAG	HEADER CONSTRUCTION 10 COURSES SURVIVE

4. Orientation	en	NW	NW BE. MAINLY BUT 2 COURSES OF STRETCHERS UTSIBLE.					
5. Associate	ed collapse	(30%	(30883)					
6. Cut & fill 1	eature #'s	NO CI	NO CUT UTBIBLE FILLS (32982) (32983) (32984).

NOT EXCAUATED. FULL EXTENT NOT UISIBLE

MUD BRICK FOUNDATION STRUCTURE FOR THE SIR COMPRISING WHAT APPEARS TO BE 'L' SHAPED CONSTRUCTION. RUBBLE CORE (32982).
