AREA: KKT.N	GRID SQUARE (S): 201D16	GRID CO-ORDINATES: E N	INITIALS & DATE: AFAM 23 i 2012	FEATURE No.: 33297									
FEATURE TYPE (For example wall, staircase, bench, foundation structure, platform etc.): wall			Full extent visible in plan: <input checked="" type="radio"/> YES / NO										
1. Dimensions (in metres)		Length: 1.16M	Width: 0.84M	Height: 0.04M									
2. Type of material(s) used		mud brick.											
3. Coursing (form of construction)		Two courses											
4. Orientation		E-W											
5. Associated collapse		—											
6. Cut & fill feature #'s		—											
7. Repaired?		—											
8. Associated floors		—											
9. Surface treatments? E.g. plaster, paint, mouldings		—											
10. Size of one component		0.40M by 0.20M											
11. Bonding material		Sandy silt											
12. Excavated		Yes/No Not Excavated											
Mini stratigraphic matrix		Abuts: <33298> Same as:

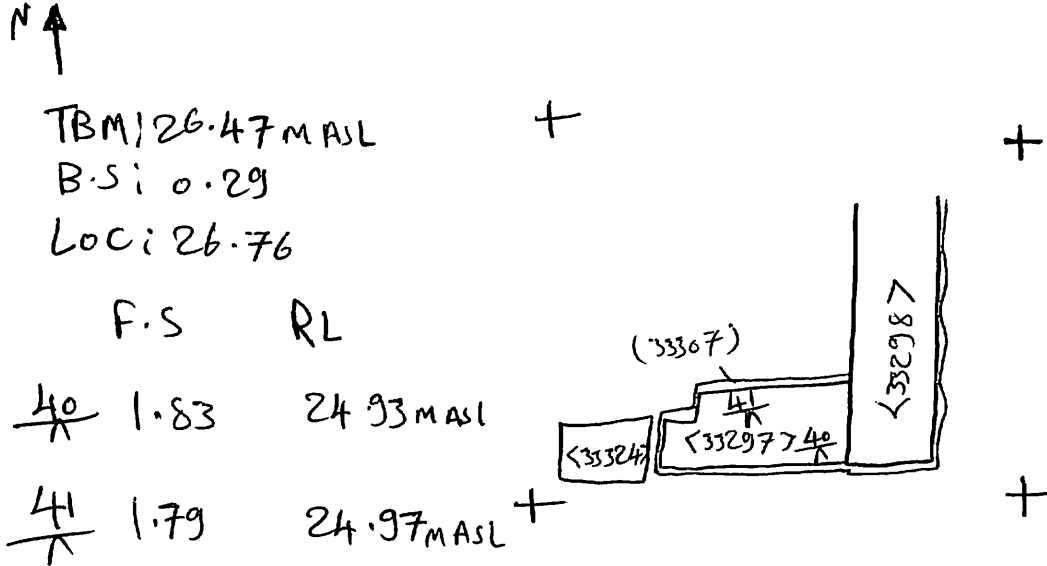
Sketch Plan - Include grid co-ordinates, North arrow, and elevations.

33324	33290		33297			33298		Abutted by: (33324) Associated features:		
	33324	33290											
	33297												
	33298												
		Bonded into: < 33297 >											
		Contiguous with:											
Discussion and interpretation:													
<p>the wall is made of mud brick, it's consists of two courses the Northern face is stretcher and the southern face is header its dimension from E-W, wall <33297> is the southern wall to room 4#¹¹²⁹³ and the northern wall to Room 4# 11289 ,</p> <p>The wall is coated with plaster layer from the southern side number (33307) ..</p> <p>the wall is bonding into wall <33298></p>
