AREA: KKT-N	GRID SQUARE (S): 201 E17 201 F17	GRID CO-ORDINATES: E N	INITIALS & DATE: EMS 23/2/12	FEATURE No.: 33317															
FEATURE TYPE (For example wall, staircase, bench, foundation structure, platform etc.): wall			Full extent visible in plan: <input checked="" type="radio"/> YES / NO																
1. Dimensions (in metres)		Length: 3.4 m	Width: 0.6 m	Height: 0.15 m															
2. Type of material(s) used		mudbrick (mud clay)																	
3. Coursing (form of construction)		the western side is headers and the eastern side is stretchers																	
4. Orientation		N-S																	
5. Associated collapse		-																	
6. Cut & fill feature #'s		-																	
7. Repaired?		-																	
8. Associated floors		-																	
9. Surface treatments? E.g. plaster, paint, mouldings		-																	
10. Size of one component		0.4 m by 0.2 m																	
11. Bonding material		sandy silt																	
12. Excavated		Yes/No Not EXCAVATED																	
Mini stratigraphic matrix		Abuts: 33326, 33303 Same as:

Sketch Plan - Include grid co-ordinates, North arrow, and elevations.

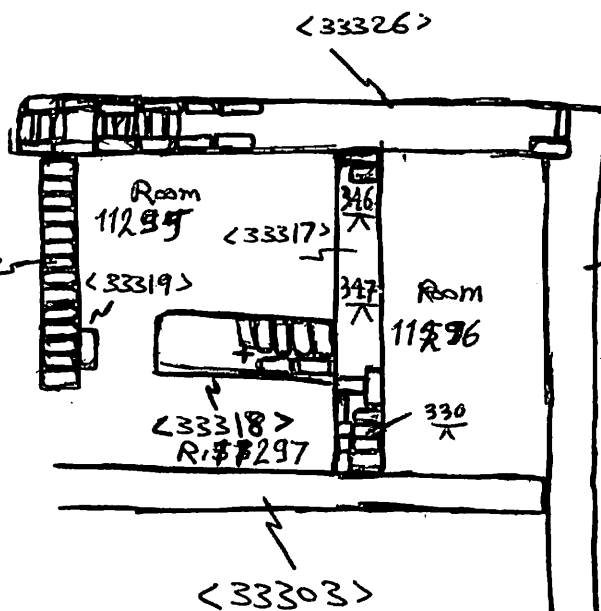
33318						33317						33326	33303	Abutted by: 33318 Associated features:		
	33318																		
	33317																		
	33326	33303																	
		Bonded into:																	
		Contiguous with:																	
Discussion and interpretation:																			
<p>N-S mudbrick wall, it was a part of the modification process which added later to divide one big space into two spaces, it was abuted by the E-W mudbrick wall < 33318 > also part of the modification to form the spaces, 11297, 11295, 11296. Space 11296 may be abandoned and stopped using after the construction of this wall because there is no entrance for that space.</p>

TBM . 26.47
 B.S. 0.43
 LOC . 26.90
 F.S RL

1.78 25.12

1.88 25.02

1.90 25.00
