AREA: KKT.N	GRID SQUARE (S): 201D17	GRID CO-ORDINATES: E N	INITIALS & DATE: MFMH HAHA	FEATURE No.: 33463
-----------------------	-----------------------------------	------------------------------	--	------------------------------

FEATURE TYPE (For example wall, staircase, bench, foundation structure, platform etc.): Door JAMP	Full extent visible in plan: <input checked="" type="radio"/> YES / NO
---	---

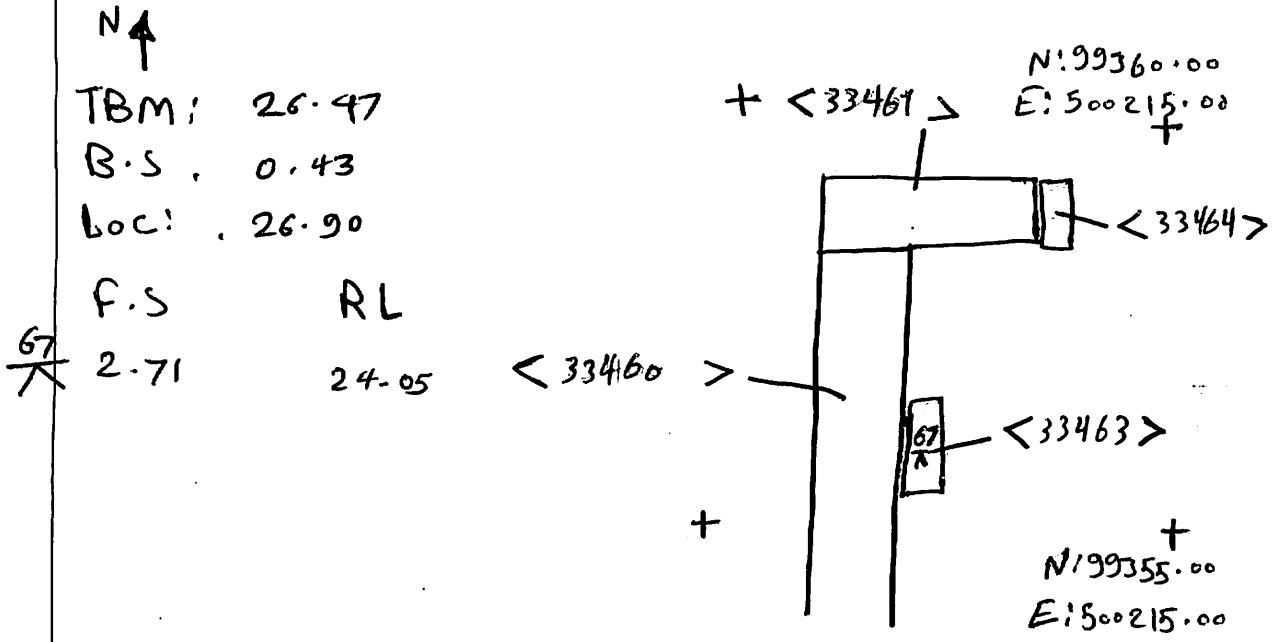
Sketch Plan - Include grid co-ordinates, North arrow, and elevations.

It is a door jamb of mud brick, abuts the wall <33460> to form an entrance leads to the room 11284 It is almost eroded.
