AREA:	GRID SQUARE (S):	GRID CO-0	ORDINATES:	- 	INITIALS & DA	TE:	FEATURE No.:
KKt-N	201014 201014	N			MFMH		33474
1.		N			1-2-2012		
	YPE (For example wal	<i>_</i>	, bench, found	Full extent visible in plan:

•	wall	Wall		(YES) / NO		
1. Dimensio	ns (in metres)	_	Length: Width: Height:			t:	
		2.00	m = 0.65 m = 0.02 m			2 m	
2. Type of m	aterial(s) used	mudi	mudbuck

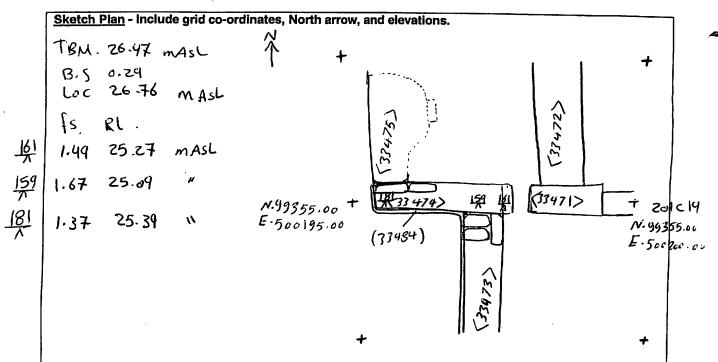
0.40 m by 0.15 m				
11. Bonding			Sandy Silt				
12. Excavated Yes(No) Not ex cavated							
Mini stratigra	·		Abuts: 33 473 > Same as:				
	33475 334	184	Abutted by: (33 4 75 > Associated features:				
	33474		Bonded into:				
	33473		Contiguous with:				
Discussion and interpretation:							
itis an	undbrick wall ([E-ω), i	it consists	of tw	10 Coasses, +	he 50	uthern
one is headers, and the Northern one is streckers; it measures 200m by

0.65 m. it is abuted by the wall < 33475 > and abuts the wall							
(33473), it is coated by a plaster layer (33484), and Located							
·							
, between	. the spaces (1	1303,11	304,117	°5),			
it migh	t beabuted e	nds in l	ts eastern	face	e with the	entr	in Ce
(according	gto selim Has	sen pla	n)·
