AREA:	GRID SQUARE (S):	GRID CO-C	RDINATES:		INITIALS & DA	řE:	FEATURE No.:	
W 4-4 1	201E 13 - EN	E			HAHA			
KKT-N	D14	N			112/2012		33480	
	YPE (For example wal	staircase,	bench, found	Full extent visible in plan:				
structure, platform etc.):					(YES)/ NO		NO	
1 Dimensio	ons (in metres)	Length:		Width				
	no (ili ilicues)			0.65 M		Height:

2. Type of m	naterial(s) used				55 M	0.15 M		
		1	L brick					
3. Coursing	(form of construction)	TW	Two courses of mud brick					
4. Orientation	on	Š-	N

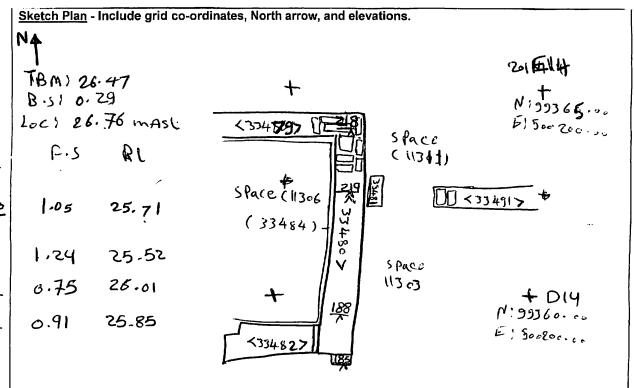
<u>Profile</u> Sketch - State direction the elevation of the feature being drawn is facing e.g. 'West Facing Elevation of Feature If feature was drawn in section then include the grid co-ordinates and elevations.

it is a wall of mud by ick (N-S) it consists of two courses, the western face is between the constern is Healer it masures 6-40M 69 0-65, it abouted 69 Wall 334817 < 33482> it is Forms the castern wall of the space (11306) it is forms the western wall of the Space (113-11-4303> Itis Coated 69 Plaster of (33484)
