•				TO TOTAL	
AREA:	GRID SQUARE (S):	_	ORDINATES:		INITIALS & DA	TE:	FEATURE No.:	
KVTAL	201 C15, 16, 17 201 B 15, 16	E			HAHA		22515	
1/1/0	(C) D 15, 16	N			12112012		33515	
FEATURE T	YPE (For example wa	I)staircase	bench found	lation	Full extent visi		lan:	
	latform etc.):		, 2011011, 104110					
		wall		YES / NO

11. Bonding	material							
			sandy silt					
12. Excavated Y			Yes(No)					
Mini stratigraphic matrix			Abuts: Same as:					
	33521		Abutted by: Associated features:			tures:		
	33 5/5		Bonded into:					
			Contiguous with:					
Discussion a	nd interpretation:		<u> </u>			 -		
E-W M	nud brick w	1911 to	the so	uth	of hou	se c	C'B

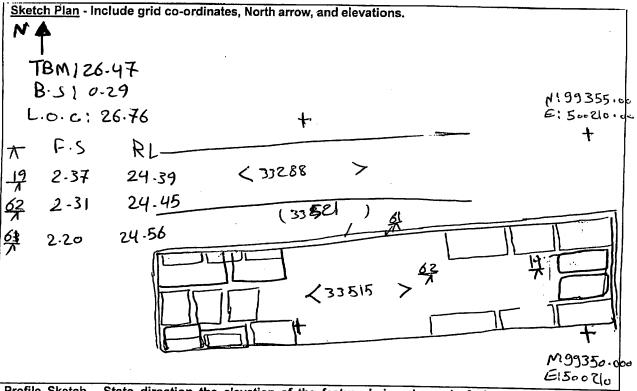
1. Dimensio	ns (in metres)	Length		Width		Height:		
ĺ		8.4	0 M	1.00	o M	0.05M		
2. Type of m	naterial(s) used	MU	mud Brick					
3. Coursing	(form of construction	\	three coursis

8. Associate	d floors							
9. Surface tro	eatments? E.g. plaste	i Diace	rais s- R	a. \				
paint, mould	ings	7145	Plastey (33521)					
10. Size of or	ne component	9:38	0.38m Long by 0.20m width

E-w mul brick wall to the south of house COB Consists of three Courses, the out Line of the wall are Strecker and between it one course Header. This wall coated with crushed tafla plaster (33521) Remember: do not just draw the architectural feature in isolation. Show how it relates to surrounding features and include details of surface treatments, repairs/modifications/damage, bonding material(s), and associated cuts. Annotate all aspects of the feature or use a Drawing Key. Measurements must be included for all aspects of the feature and surrounding features.
